CALSPAN REPORT NUMBER: 8404-6

**VEHICLE-TO-VEHICLE  
132° FRONTAL IMPACT OF A  
A 1987 TOYOTA MR2 2-DOOR COUPE  
TRAVELING 72.4 KPH INTO THE  
RIGHT FRONT CORNER OF 1994 TOYOTA  
COROLLA 4-DOOR SEDAN TRAVELING 24.1 KPH**

CALSPAN TEST NUMBER: A109-6-1732

November 11, 1997

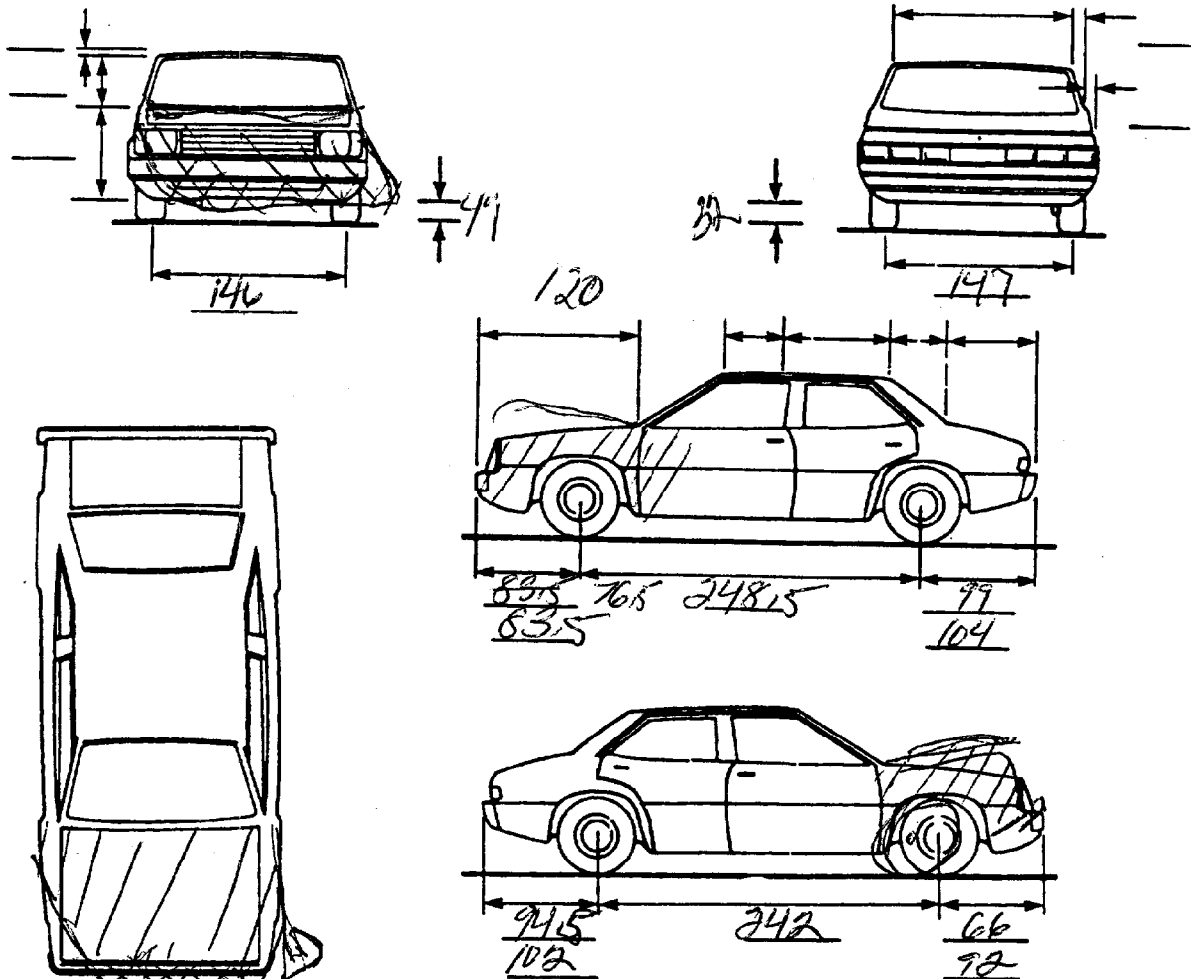
### VEHICLE DAMAGE SKETCH

Specific Impact No.	Location of Direct Damage	Location of Field L	Location of Max Crush
1	front bumper extends from RF BC → DOCM left	entire front bumper	C4

Specific Impact Number	Plane of Impact C-Measurements	Direct Damage		Field L	C <sub>1</sub>	C <sub>2</sub>	C <sub>3</sub>	C <sub>4</sub>	C <sub>5</sub>	C <sub>6</sub>	±D
		Width (CDC)	Max Crush								
1	front bumper	120cm		140.5	7.5	6	15.5	24	25.75	33.5	±12
	free space				12	6	2	2	6	12	
	resultant crush	120cm	22	140.5	0	0	13.5	22	19.75	21.5	±12

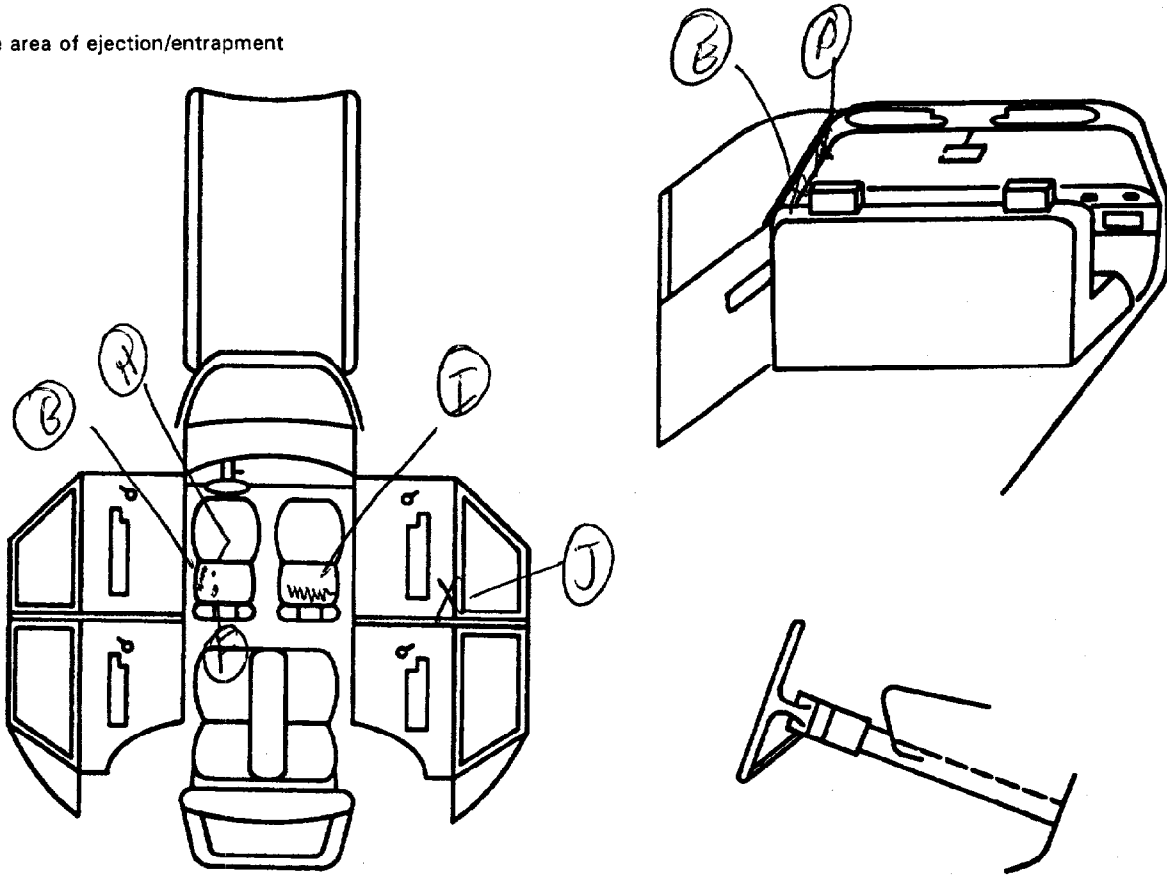
### VEHICLE INTERIOR SKETCHES

- A** Begins 17 cm right of the knee bolster's left aspect and 1.5 cm inferior of the junction of the instrument panel and knee bolster, extending 5 cm right and 3 cm down.

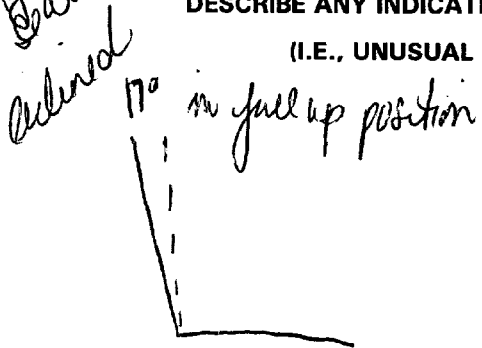
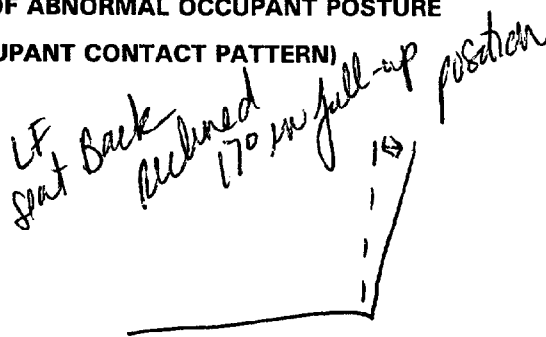
RF passengers  
Seat Back  
Reclined
